Monitoring Completed Navigation Projects Program

Inspections of Previously Monitored Rubble-Mound Coastal Structures

Robert R. Bottin, Jr., Larry R. Tolliver, and
Glenn B. Myrick

September 2004

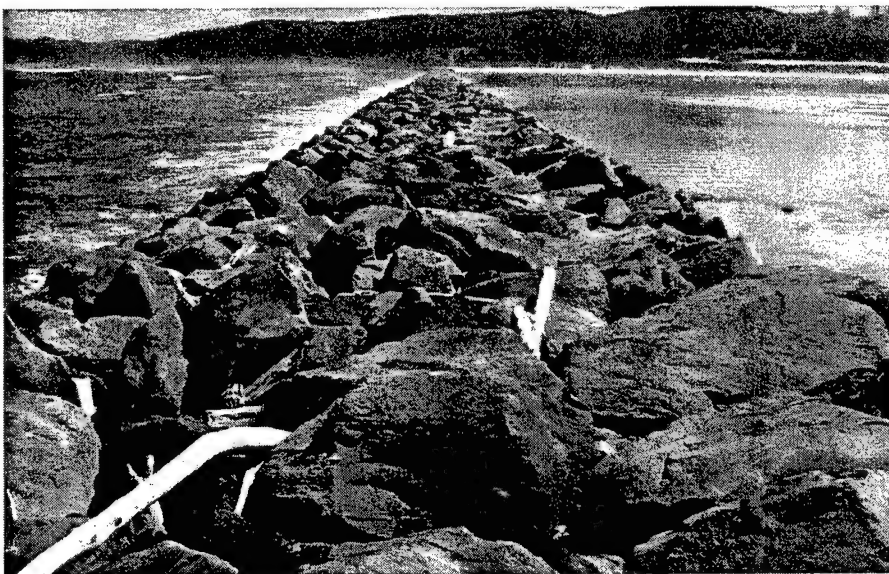
The most recent walking inspection of the Umpqua training jetty and south jetty was conducted on 26 August 2003. Observations revealed the conditions of the structures were generally similar to the previous inspection of 1997. A small void was noted, however, where the training jetty tied into the revetment on the landward end. Small voids in the crest as well as slight subsidence in a few areas were also observed along the crest of the training jetty. A view of the training jetty is shown in Figure 12. The breach at the head of the south jetty appeared also to have subsided slightly since it was below the water level (Figure 13). Slight subsidence was also noted in a couple of areas on the crest of the south jetty. The slopes of both structures were in good condition except for the void and breach areas.

Figure 12. View of Umpqua River training jetty (looking shoreward)

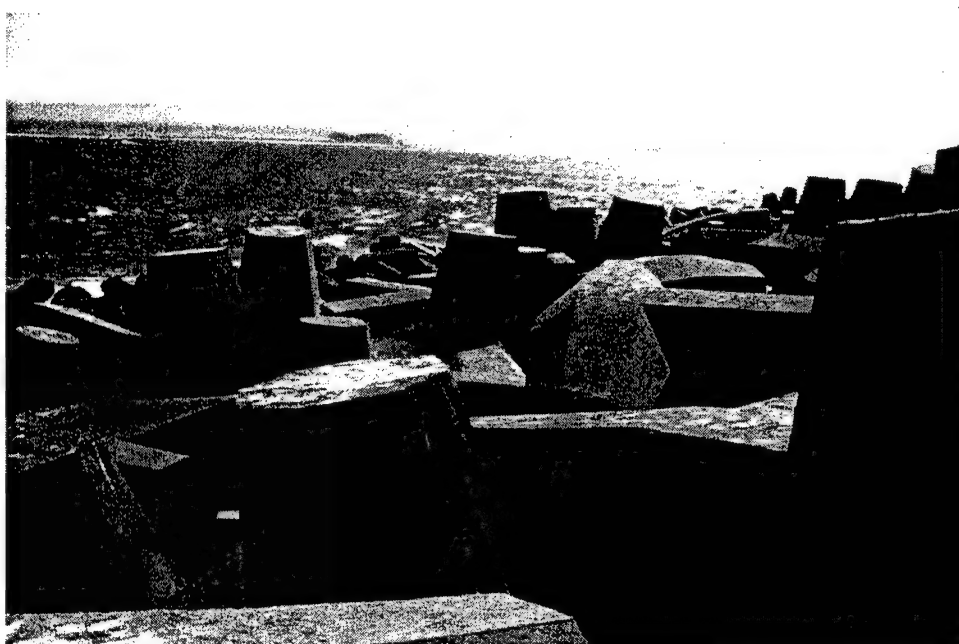
Figure 18. Close-up view of 38,100-kg (42-ton) dolosse armor cover

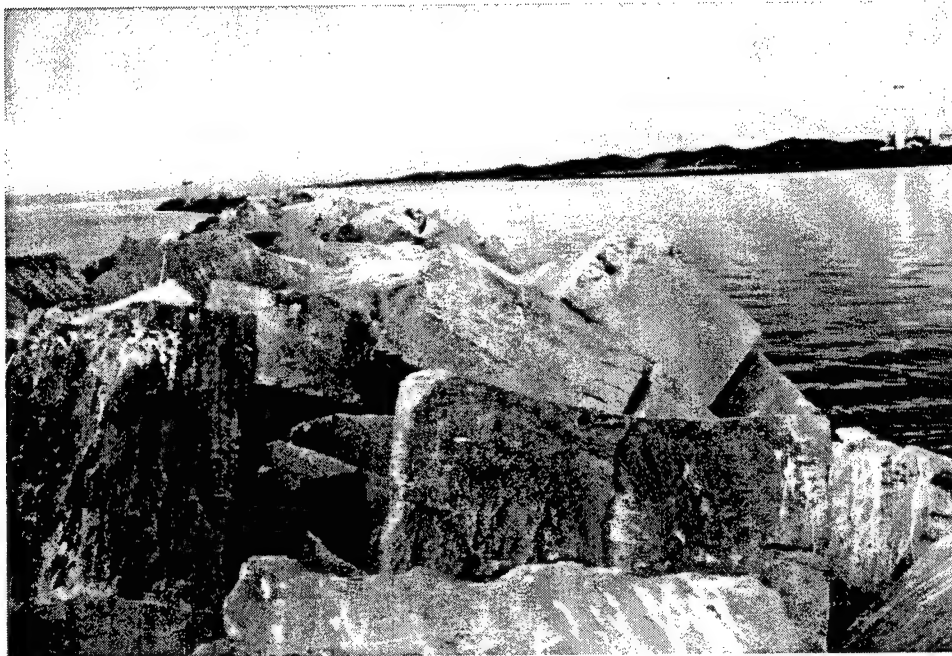
A walking inspection of the Burns Harbor north breakwater (Figure 20) was conducted on 17 June 1998. The elevation of the breakwater was compared to topography data obtained previously during the photogrammetric analysis. Numerous sections of the structure appeared to have lost el since the previous survey. The inspection also indicated several voids in the breakwater. It appeared that continued deterioration of the breakwater had occurred since the 1994/1995 inspection. It was noted during the inspection, however, that a barge was working lakeward of the north breakwater. Construction of a submerged, offshore reef breakwater was ongoing. The submerged reef was designed to reduce wave heights at the north breakwater during storms, thus resulting in less structure damage as well as decreased wave heights in the harbor. Construction of the reef breakwater was completed in the fall of 1998. Model studies were used to determine reef layout (Acuff and Bottin 1995) and ensure stability (Carver and Wright 1995).

The breakwater (Figure 20) was again monitored in 1999 through limited ground surveys, aerial photography, photogrammetric analysis, and a broken armor unit survey as part of the "Periodic Inspections" work unit of the MCNP Program (Bottin and Tibbetts 2000). Examination of breakwater topography indicated continued loss of structure el as opposed to the 1994/1995 study. Cumulatively, about 46 percent of the total length of the breakwater was below its design el (versus 24 percent previously). As in the previous analysis, the structure crest width was less than its design and steep slopes were observed on the harbor side. A broken armor unit survey revealed 225 broken/cracked armor stones, as opposed to 165 previously. It was noted that most the additional breakage occurred along the harbor-side slope. In 1999, about 44 percent of the broken armor stones were located on the eastern one-third of the breakwater versus 50 percent in the previous study. The 1999 periodic inspection of the breakwater not only determined changes in the armor field since the previous

Figure 20. View of Burns Harbor breakwater in 1999 (looking east)

Subsequent to the 1999 periodic inspection of the structure, numerous repairs were made to the north breakwater. Between 1999 and 2003, 174,263,923 kg (192,092 tons) of stone were placed on the structure. Repairs to the lakeside were conducted from sta 0+00 to 23+70 and sta 32+50 to 40+65; and repairs on the harbor side occurred from sta 10+50 to 46+30. Repairs involved the placement of stone to flatten the breakwater slopes and raise the crest to design levels. Additional stone placement is scheduled for 2004-2005.

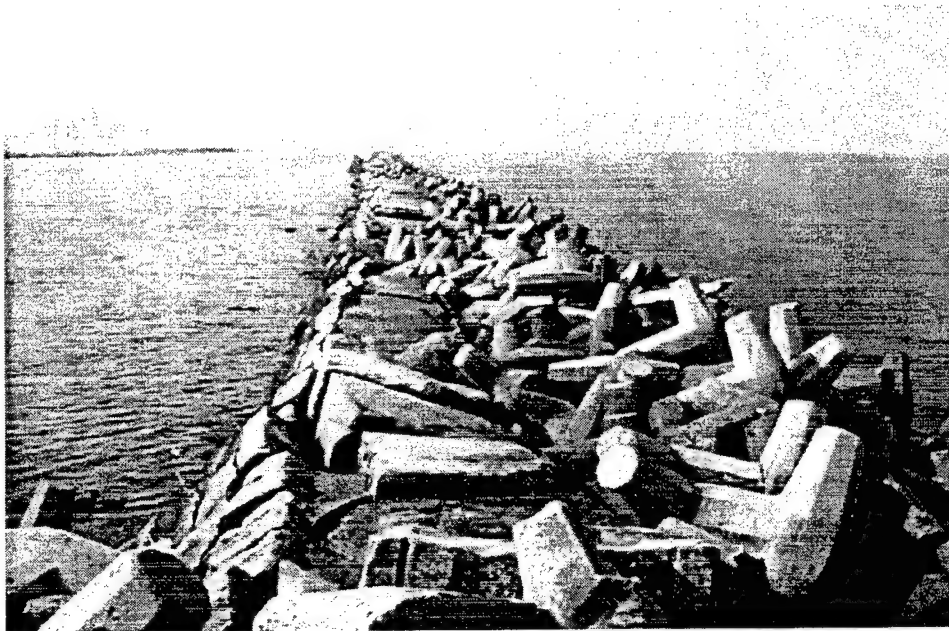
The most recent walking inspection was conducted on 10 June 2004. In general, it appears the structure has not changed much since the last walking inspection. Most armor units appeared to be in similar positions when compared to the 1993 aerial photographs. There were some areas with isolated changes, however. A void was noted on the lake side of the breakwater at the waterline between sta 230+40 and 230+70 (Figure 26). Other low areas on the lakeside slope were observed at stas 256+60, 257+40 – 257+70, and 260+70. In addition, slight subsidence of the crest was noted between sta 250+30 and 250+50. Some additional 3,628-kg (4-ton) dolosse had been placed on the structure trunk since the 1997 walking inspection. Excessive vegetation (bushes and trees) was also

observed on some portions of the breakwater. The structure was in fair to good condition and appeared to be functioning well.

Figure 24. View of 1,814-kg (2-ton) dolosse along trunk of Cleveland Harbor east breakwater

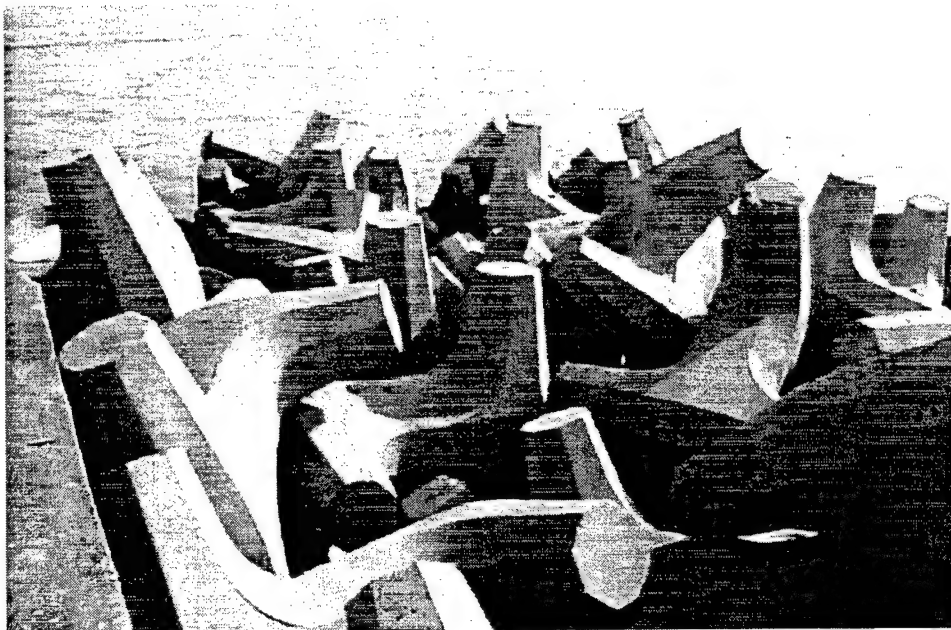
Figure 25. View of 3,628-kg (4-ton) dolosse at head of Cleveland Harbor east breakwater

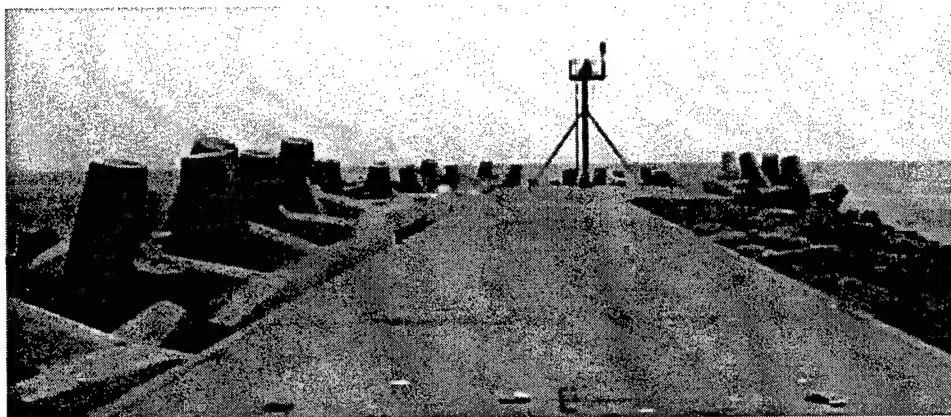
Figure 31. View of Manasquan Inlet north jetty

The most recent walking inspection of the Manasquan Inlet jetties was conducted on 28 May 2003. Armor unit positions were compared to photographs obtained during the photogrammetric survey of 1998. It appeared that insignificant changes had occurred. Armor unit positions appeared to be in the same locations and no additional breakage had occurred. It was noted that many of the dolosse were exhibiting hairline cracks. These may be concrete-curing cracks aggravated by weathering for the last 20-plus years. Spalling may occur at some point in the future. The armor units were structurally and functionally sound, and the structures appeared to be in excellent condition.

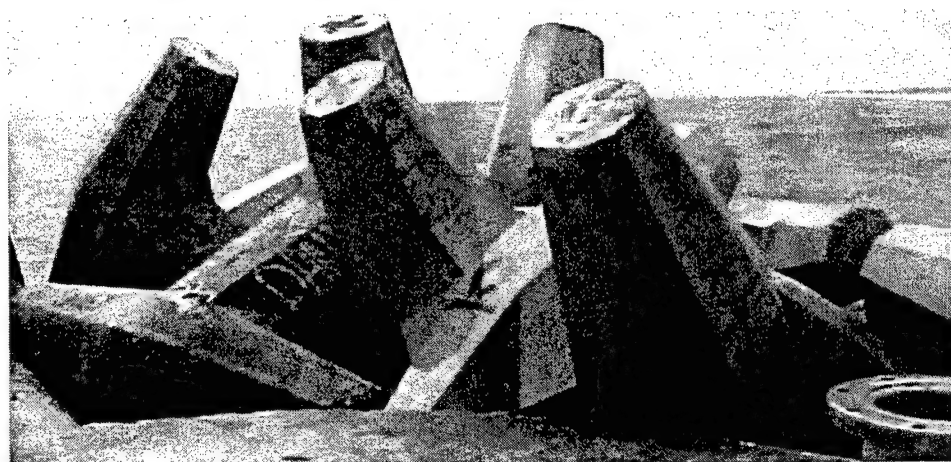
Subsequent to the June 1997 walking inspection, both jetties' void areas were rehabilitated (in October 1997) with 17,235-kg (19-ton) Core-Loc® armor units. Twenty nine Core-Locs were placed on the north jetty and 16 on the south jetty interlocking with the existing dolosse. In addition, nine dolosse were repositioned to improve interlocking and several broken units were removed. Other dolosse were repositioned slightly to provide space for the new Core-Locs to integrate into the overall protection plan. A view of a Core-Loc armor unit is shown in Figure 32.

Figure 32. View of a 17,235-kg (19-ton) Core-Loc armor unit placed on Manasquan Inlet jetties

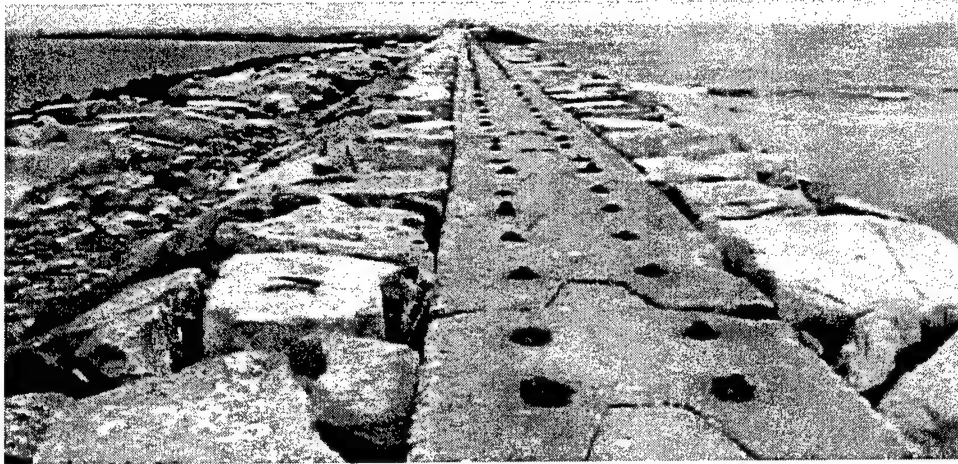
The most recent walking inspection of the Ocean City Inlet south jetty and headland breakwaters was conducted on 29 May 2003. Armor stone positions were compared to photographs obtained previously in 1997. The rehabilitated south jetty (to sta 13+00, Figure 34) and the three headland breakwaters (Figure 35) appeared to be in excellent condition. No voids were noted, no broken armor stones observed, and the cross sections again appeared to be as-built. It was noted that slight spalling of the precast concrete core was occurring (probably due to weathering), but the structure was structurally and functionally sound. The recently rehabilitated outer portion of the south jetty (beyond sta 13+00) also appeared to be in excellent condition (Figure 36).

Figure 34. View of inner portion (to sta 13+00) of rehabilitated Ocean City inlet south jetty trunk

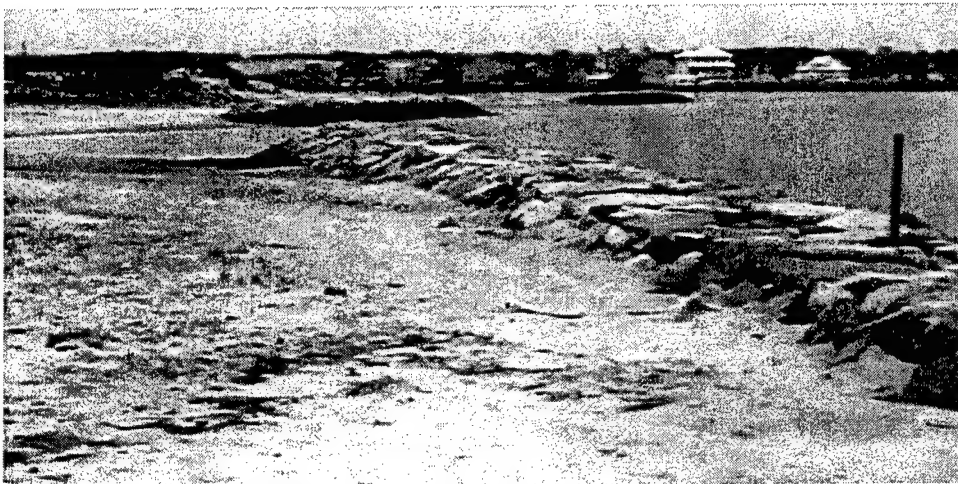
Figure 35. Headland breakwaters at Ocean City inlet constructed to stabilize shoreline
